HOUSATONIC RIVER BASIN  
NORFOLK, CONNECTICUT

**NORFOLK BROOK DAM  
CT 00485**

**PHASE I INSPECTION REPORT  
NATIONAL DAM INSPECTION PROGRAM**

MARCH 1981

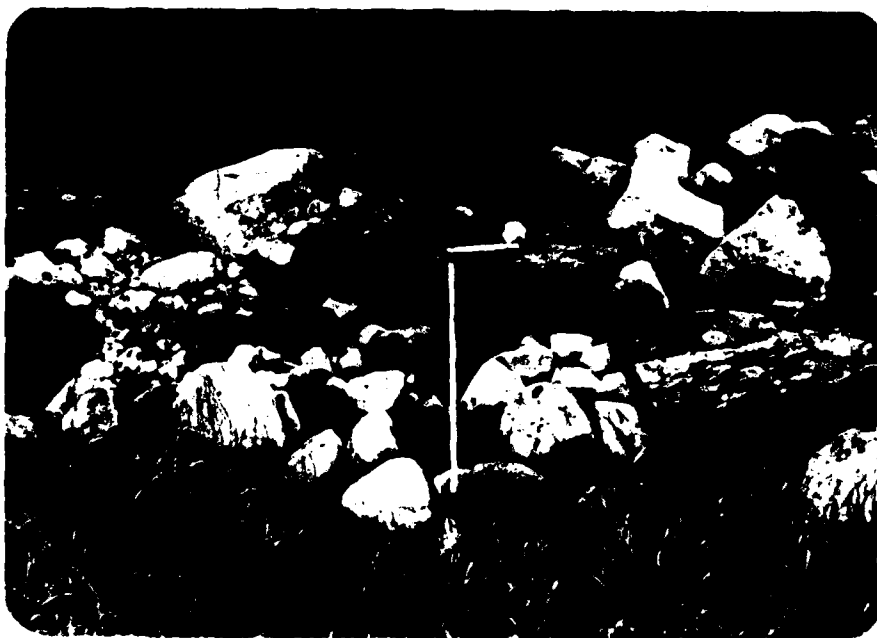
PHOTO NO. 4

RIPRAP ALONG DOWNSTREAM TOE OF DAM.

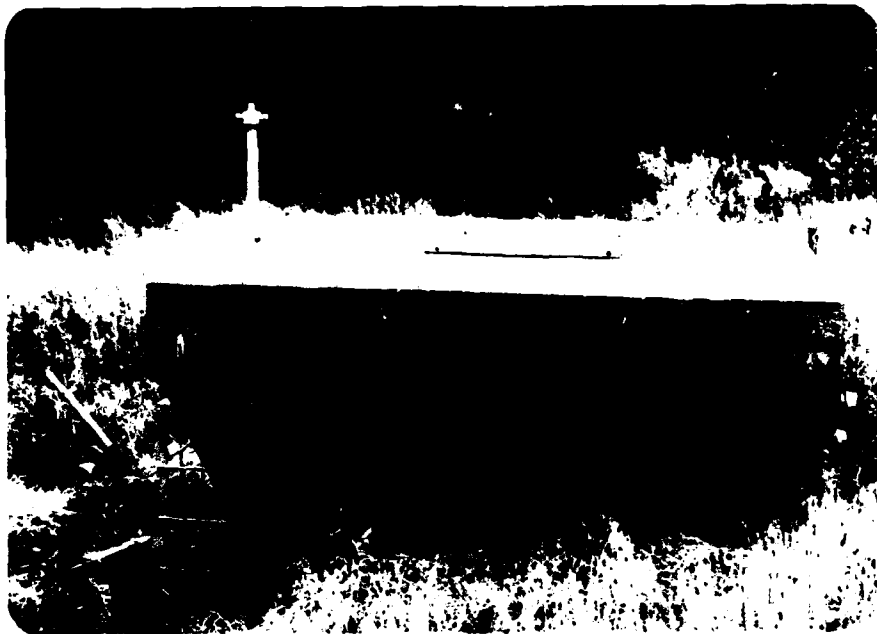
PHOTO NO. 9

The appurtenant structures consist of the principal spillway and outlet works, and the emergency spillway. The inlet structure is a reinforced concrete drop inlet with a 15-inch slide gate for draining the sediment pond, Photos 9 and 10. The gate appears to be operational. The slide gate is protected by a painted steel trash rack which is beginning to rust. The drop inlet is protected by a galvanized steel pipe trash rack. The concrete was in good condition with no cracking or spalling noted.

PRINCIPAL SPILLWAY INTAKE STRUCTURE.
